# Enbridge Line 5 Relocation Project Case Study – Enbridge Check Valve Installation Project

Enbridge Check Valve Installation Project near the Bad River

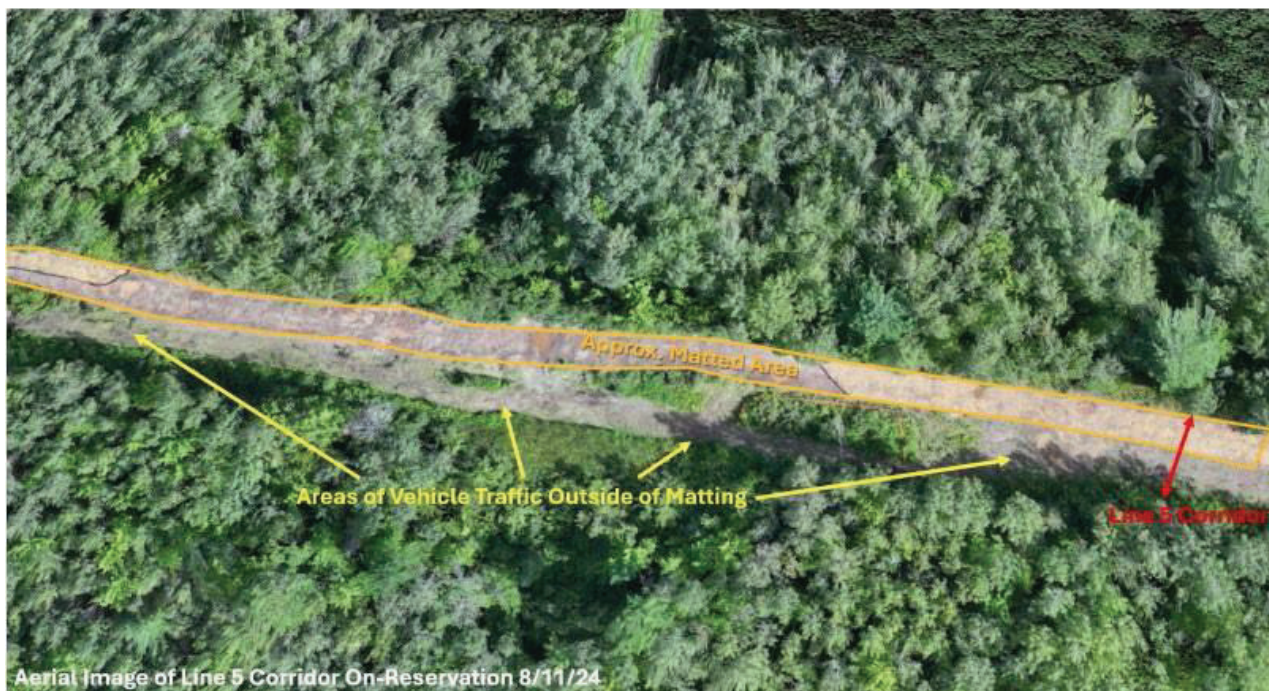
decisions based on these assurances to ensure adequate protection of cultural species and the design of the entrance to the site from the nearest roadway. However, as you can see from Figure 1 - Figure 3, heavy vehicle traffic occurred off the matting and through areas that should not have been directly impacted by construction vehicles. Construction fencing was only placed to protect targeted plant species within 5 feet of the proposed matting locations—rather than all locations where the target plant was surveyed—due to assurances from Enbridge staff that all activity was to remain on the installed construction matting. Post-construction survey will be needed to determine the full extent of harm to protected plants from this unpermitted activity.

*Figure 1. An annotated aerial image taken by drone over the Enbridge Line 5 corridor on August 11, 2024, shows a portion of the access route into a construction site where matting has been removed and some straw bales and sediment logs installed. Noted within the image are where the construction mats were placed per permit approval, the general width of Enbridge's Line 5 corridor, and areas where vehicle traffic clearly occurred not on the construction mats.*

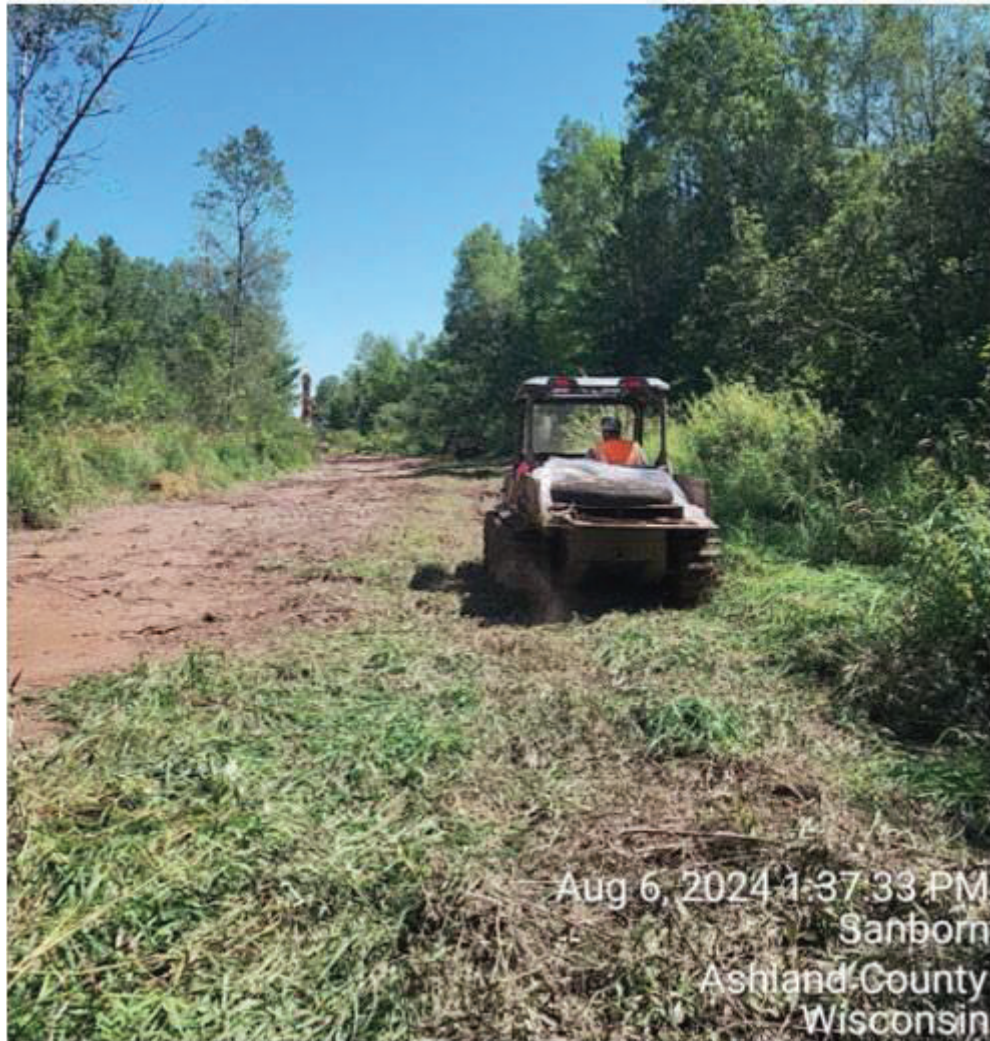
*Figure 2. Photo from August 6, 2024, showing an Enbridge crew member operating a tracked vehicle off of the construction matting. The construction matting was placed in the muddy area shown on the left side of the photo—in the background, you can see the excavator that is picking up the construction matting as the Enbridge crew demobilizes from the site.*

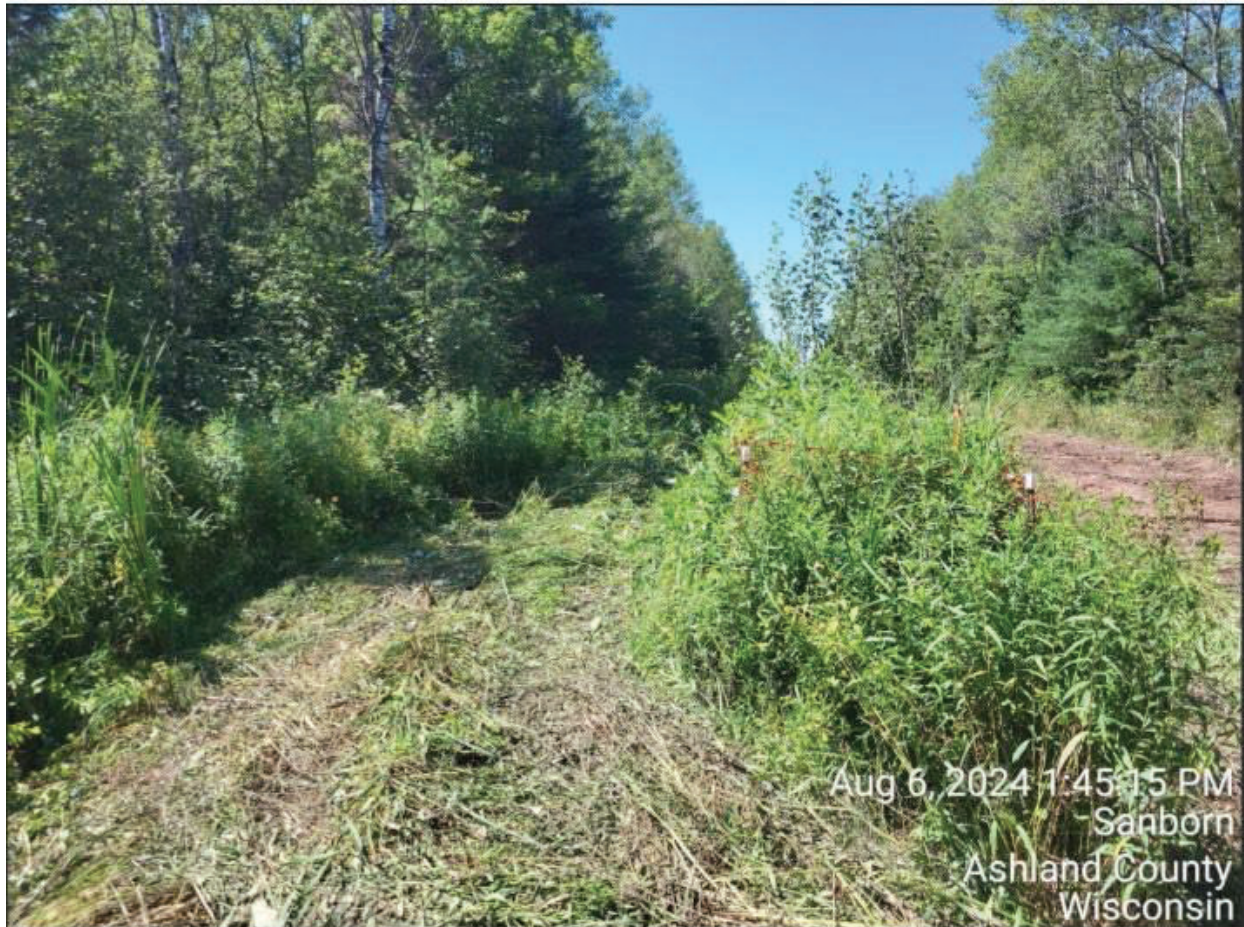
*Figure 3. Areas of orange fencing were only installed around the culturally important plants that Enbridge was required to protect per tribal and federal permits when the plants were located within 5 feet of the construction matting. The lack of the orange construction fencing was not indicative of the lack of the protected plants, which were found at multiple locations along the corridor. The photo shows where Enbridge contractors drove around the fenced area (left side of the photo) instead of remaining on the construction matting, which would have been placed on the right side of the photo.*

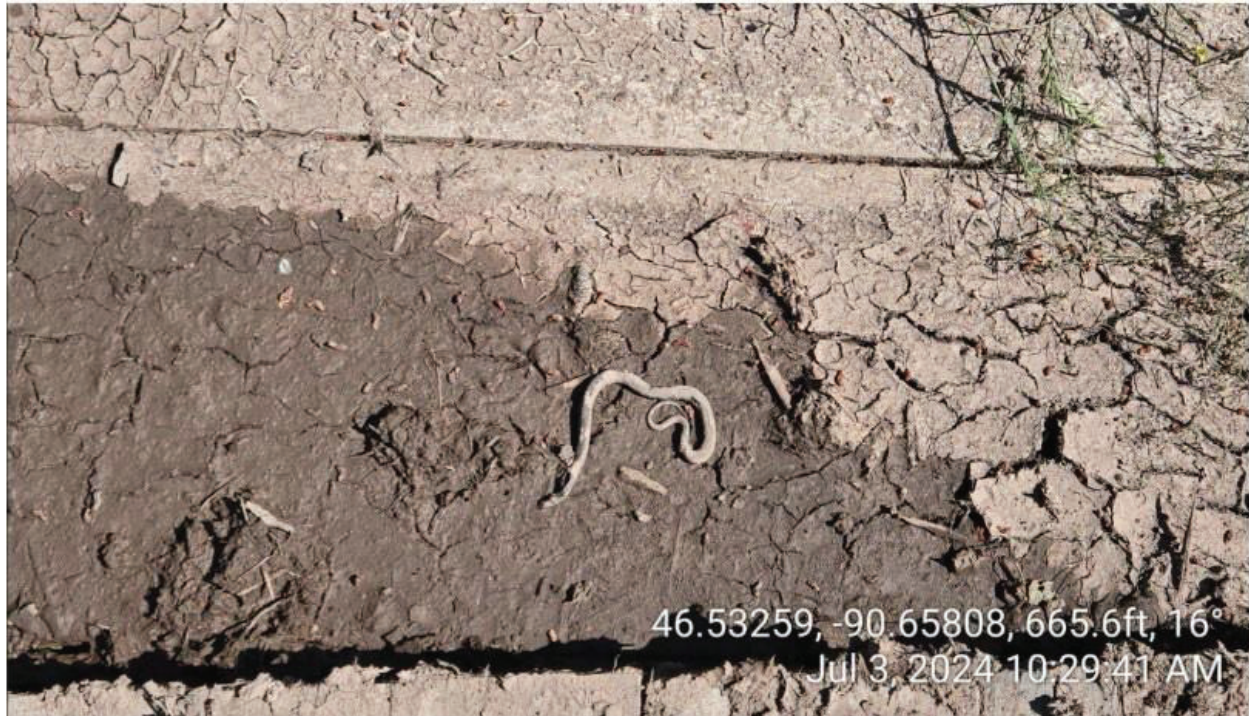
Amphibians and reptiles were also negatively impacted from the construction, with some direct take incidence documented (Figure 4) and sedimentation into the aquatic habitats nearby the site (Figure 5) affecting water quality and altering their suitability for aquatic and semi-aquatic organisms. Amphibians, like the adult frog in the picture, can still be found in the wetland; however, water quality was affected, and the suitability of this wetland for any larval amphibians that may have hatched out in the spring is drastically reduced. This illustrates the impact that causes or may contribute to an adverse effect on human, plant, animal, or aquatic life, or in quantities that may interfere with the normal propagation, growth, and survival of indigenous

*Figure 4. A dead snake alongside the construction matting used in Enbridge's Line 5 workspace. Snakes were observed by tribal staff as sunning themselves on construction matting—whether this snake was hiding or more obvious on top, it did not survive its encounter with the construction matting.*

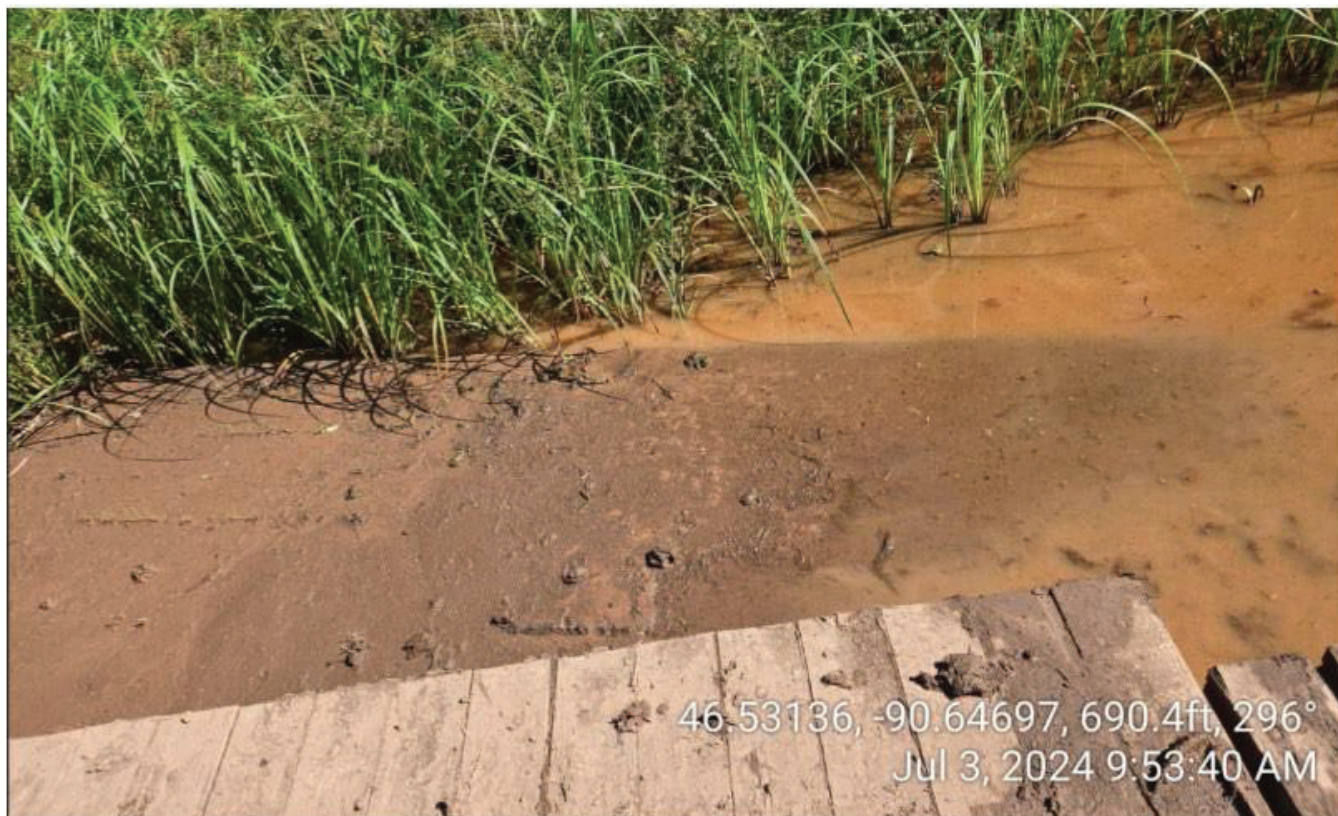
Wetlands along the matted construction route were drastically altered by the placement of the mats which lasted from 49 to 84 days<sup>3</sup>. As shown in Figure 5, a wetland is impacted by mud, a pollutant, pushed out from underneath the construction matting, and the sediments released as mud transferred by vehicle traffic are left on the matting and washed off into the nearby wetland. Wetlands were affected due to the displacement of soils (Figure 6 and 7) from the wetlands that required regrading of the soils after the removal of the matting (Figure 8 and Figure 9) and soil sedimentation into adjacent parts of the wetland downstream of the construction zone (Figure 10).

*Figure 5. A wetland impacted by the mud pushed out from underneath the construction matting, and the sediments released as mud transferred by vehicle traffic is left on the matting and washed off into the nearby wetland amphibians, like the adult frog in the picture, can still be found in the wetland; however, water quality was effected, and the suitability of this wetland for any larval amphibians that may have hatched out in the spring is drastically reduced.*

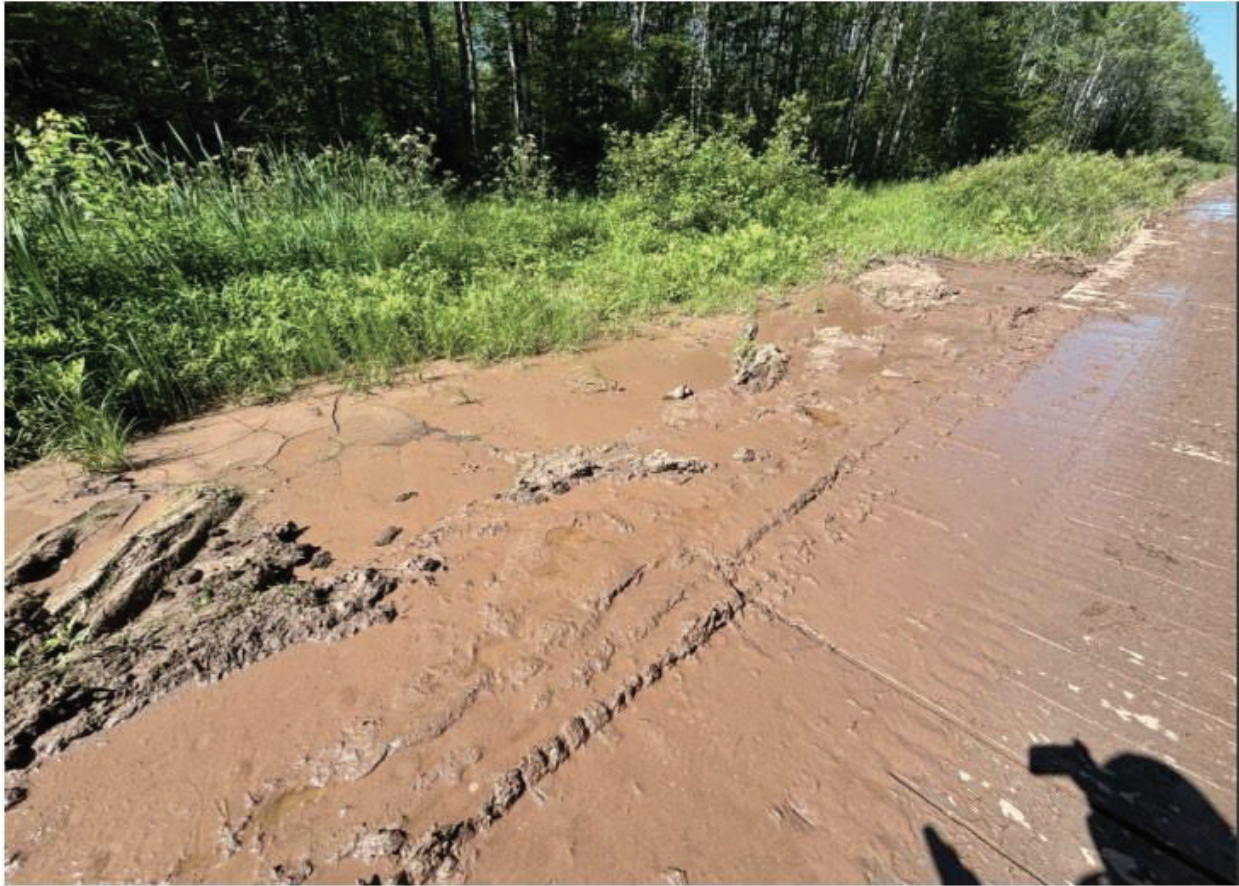
*Figure 6. Soils being pushed out from under the construction matting and into adjacent wetlands as mats sink further into the soft substrate of the wetland, they were placed on top of from the vehicle traffic.*

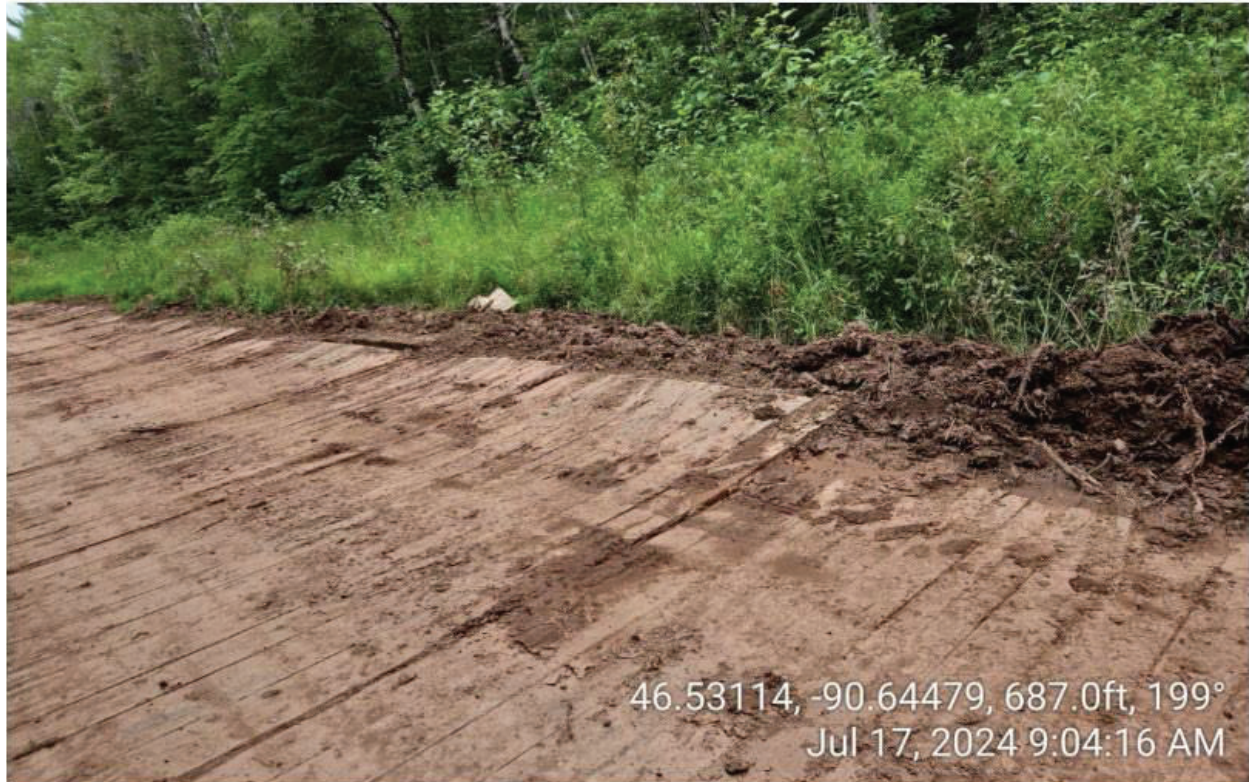
*Figure 7. Soils are being pushed out from under the construction matting at drier areas along the access road (as compared to Figure 6) as soft topsoil is displaced from construction matting, which is supposed to be “protective” of the underlying landscape.*

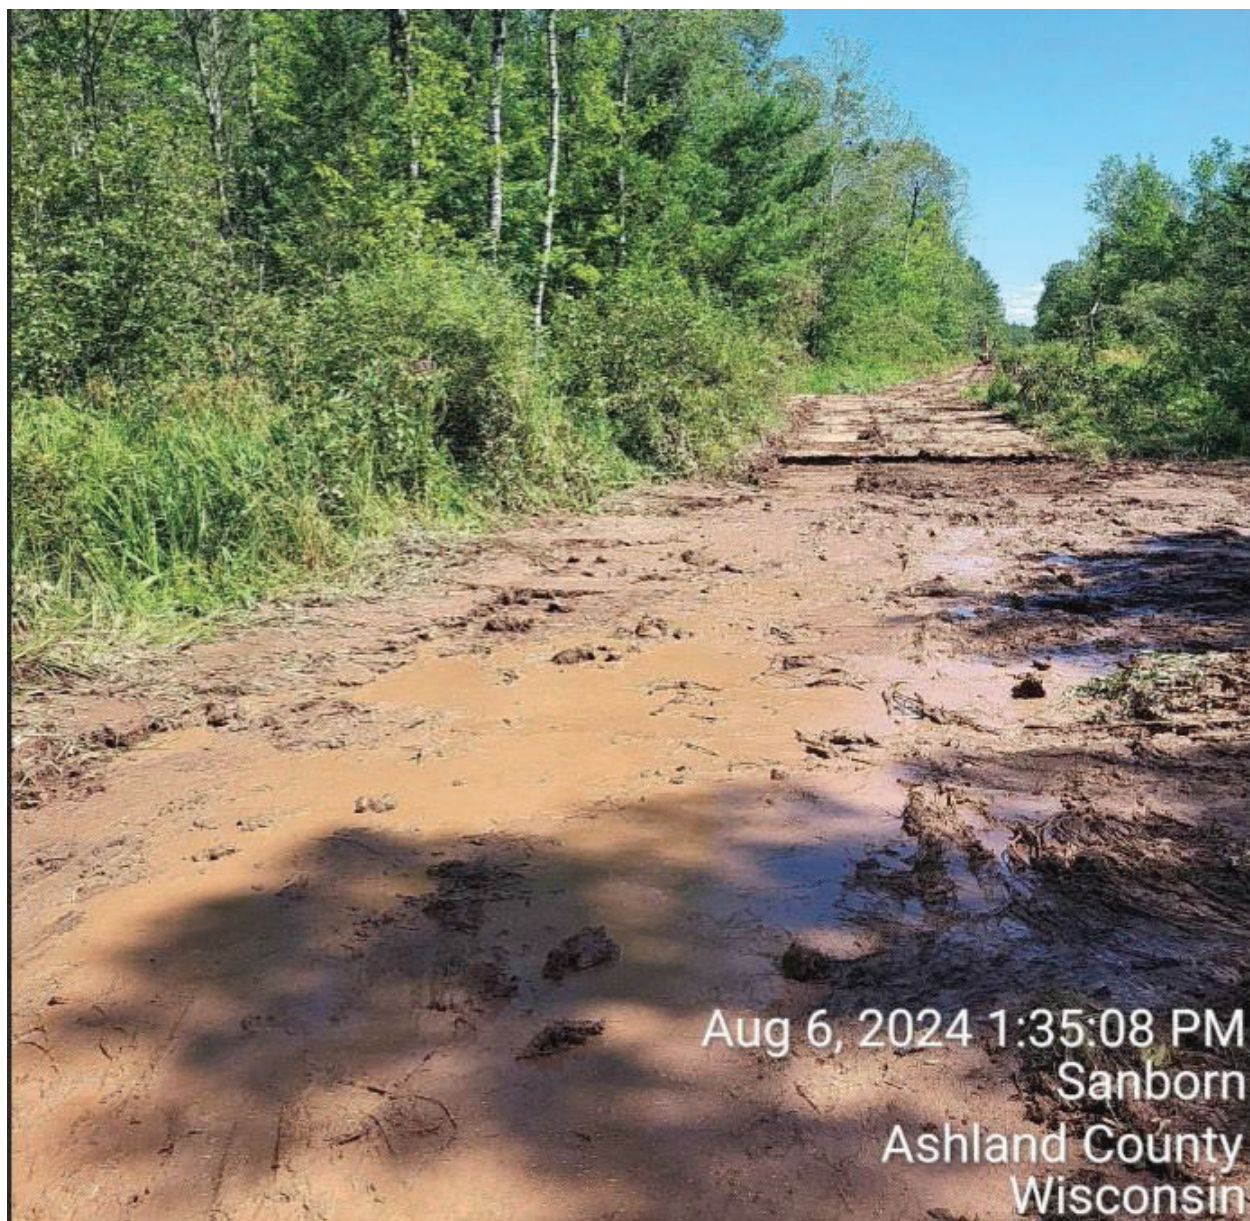
*Figure 8. The photo shows the condition of the wetlands along the access route immediately after construction matting was removed. As you can see in the photo, the limits of soil disturbance are wider than the construction matting (see the width of construction matting in the background of the image).*

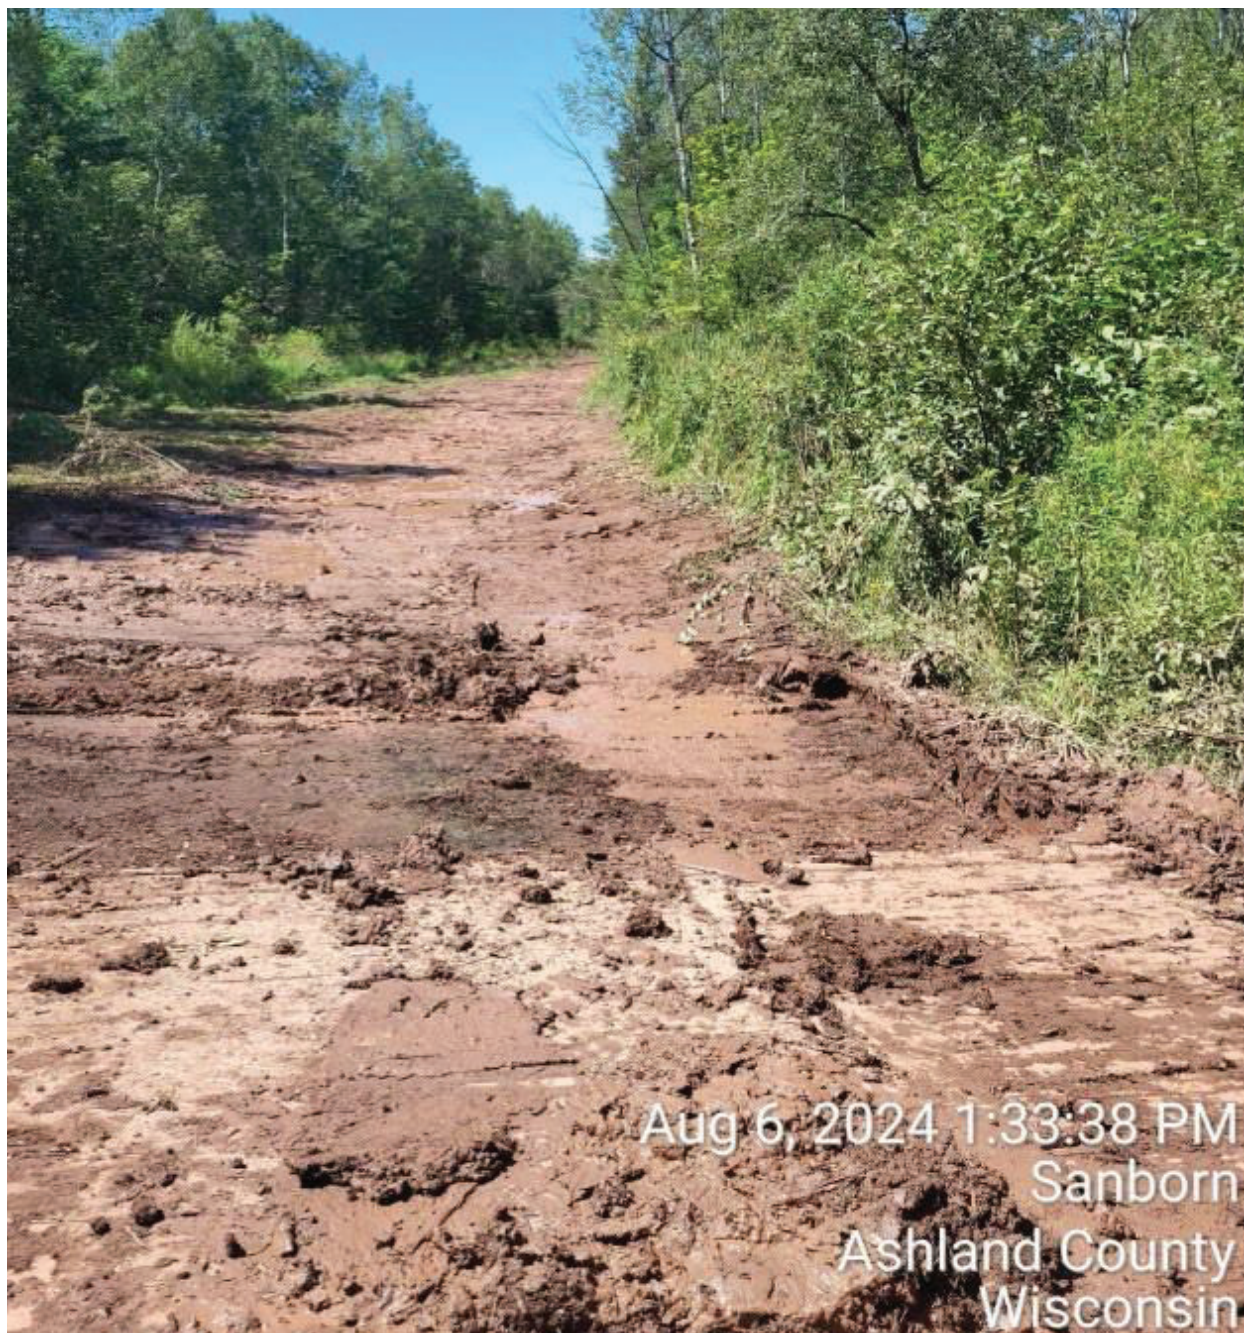
*Figure 9. The photo shows a portion of the access route where the construction matting was removed—in the background, the exposed soils have been “smoothed” with the backhoe bucket, while the area in the foreground is still rough and uneven from the matting being installed and its removal.*

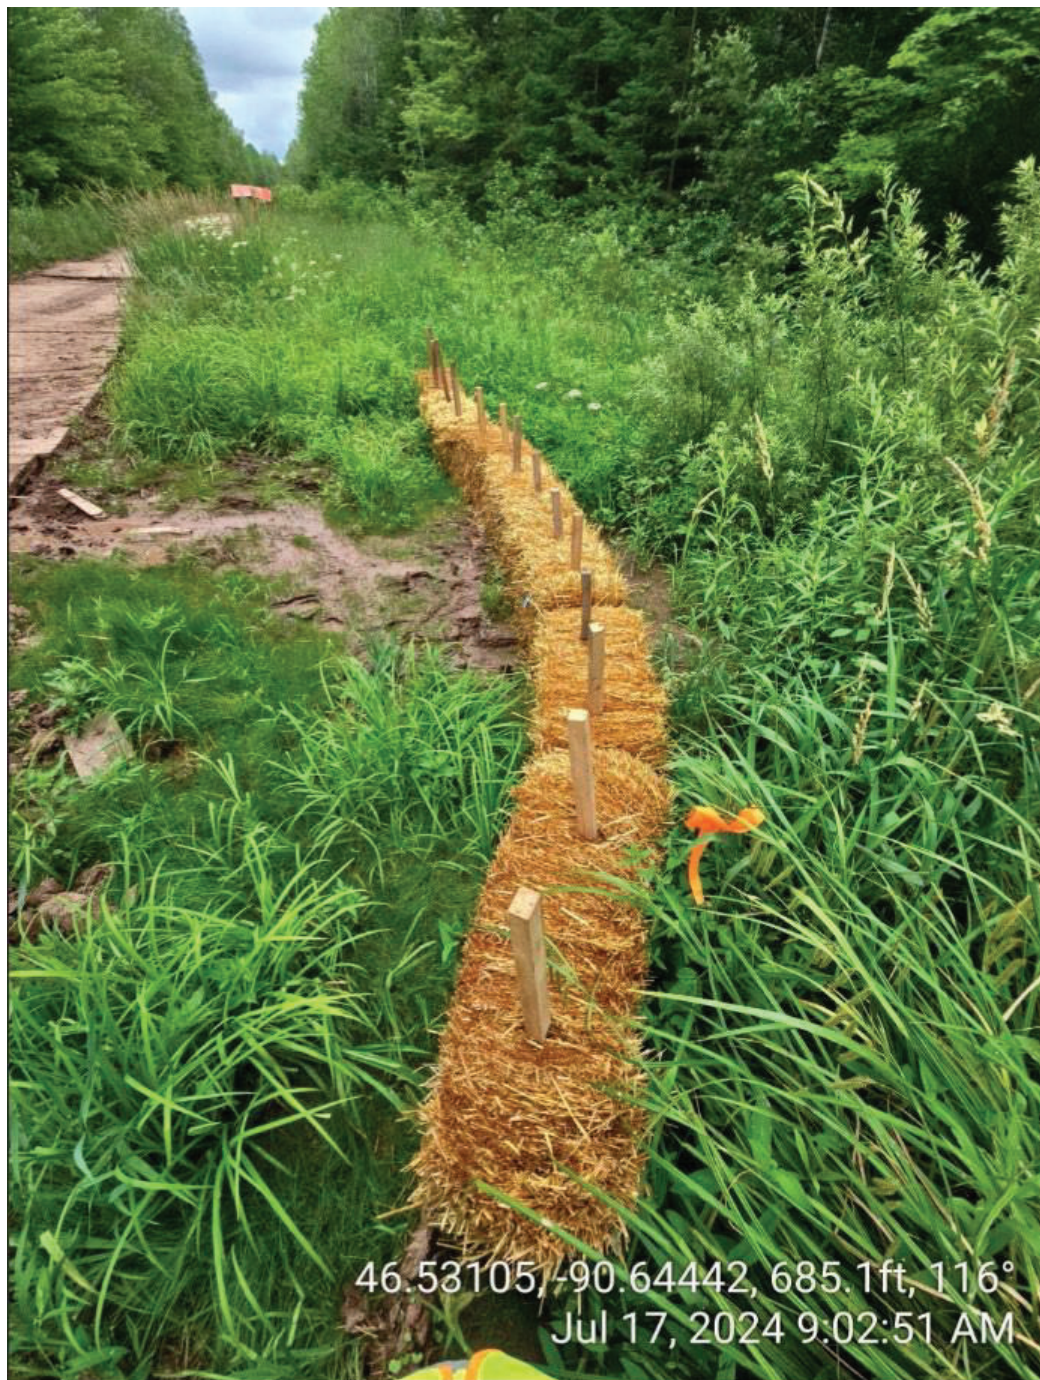
The longer matting is left in a wetland and the more crossings made over it, the greater the impact on the wetland will be as the matting will sink into the substrate and cause a large amount of disturbance once removed. This also impacts sedimentation off the construction sites and access routes (Figure 10) and damages the aquatic communities (e.g., native plants) already present. MNRD has documented severe impacts on vegetation from construction matting where the matting was installed for less than two months (Figure 12).

*Figure 10. The photo shows the installation of straw bales to attempt to contain sediment from soils disturbed by the construction matting moving outside of the construction corridor and farther into the wetlands. Sediment deposits can be seen on both sides of the straw bales, indicating that either these sediment control practices were not implemented when they should have been, or they were not installed correctly.*

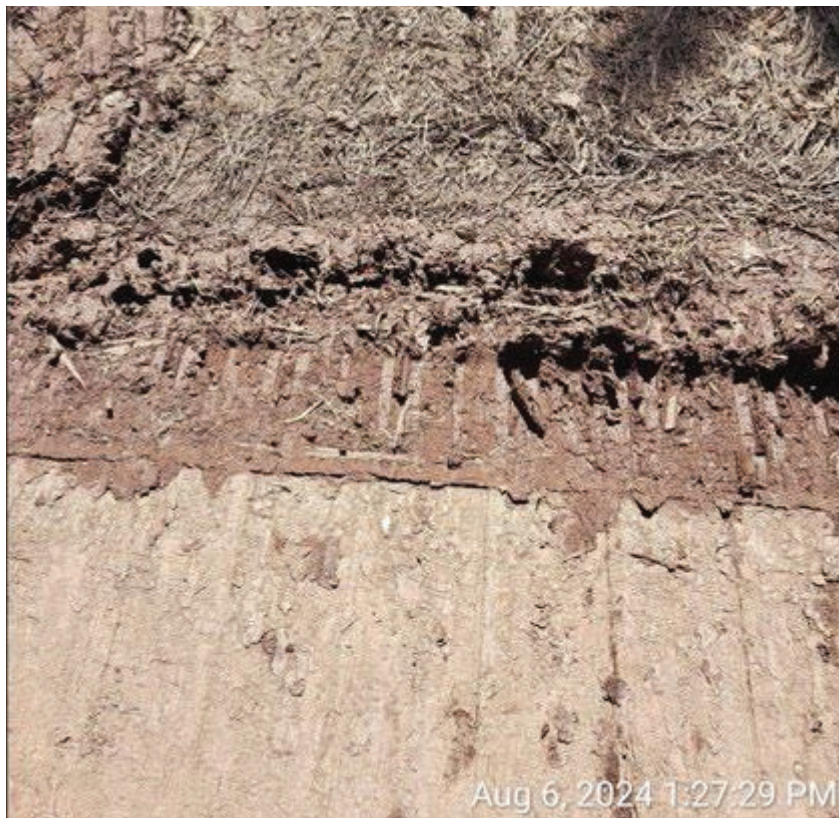
Aside from the construction matting causing soil dispersion, it also caused soil compaction, with MNRD staff reporting that in some areas the soils were so compacted that it took them a moment to realize that they were not standing on the timber matting at that location anymore (Figure 11). Greater than six inches of soil compaction was documented after the matting was removed. Soil compaction can lead to increased runoff and less infiltration as well as slow revegetation in areas and change the overall plant composition of a site.

*Figure 11. The photo of soil compaction left after the removal of the timber matting along an access route on the Bad River Reservation. The traffic along the matting pushed softer soils out from under the matting (built-up mud towards the top of the picture) and then compressed the soils that remained to the point they were as hard as the timbers that left the pattern on them (bottom of the photo).*

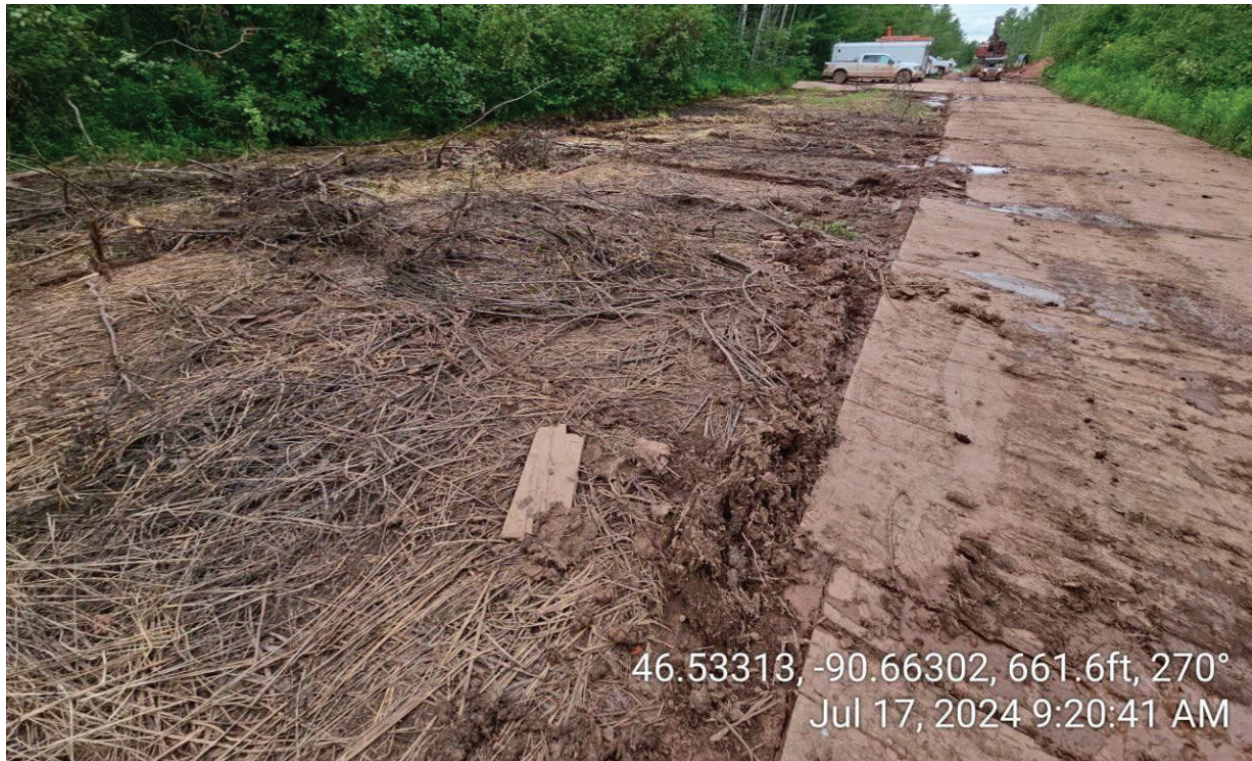
*Figure 12. A photo from July 17, 2024, showing a location where timber matting was installed, then removed, for construction activities on the Reservation on Line 5.*
