Flood of July 2016 in Northern Wisconsin and the Bad River Reservation

Scientific Investigations Report 2017–5029

By Faith A. Fitzpatrick, Eric D. Dantoin, Naomi Tillison, Kara M. Watson,
Robert J. Waschbusch, and James D. Blount

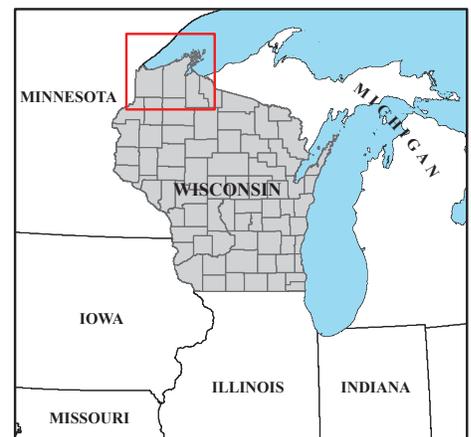
Figure 1. Study area in northern Wisconsin showing streamgages, river basins, and Bad River Reservation.

Immediately following the flood, the U.S. Geological Survey (USGS) and the Natural Resources Department of the Bad River Band of the Lake Superior Chippewa Tribe (hereafter referred to as the Bad River Tribe) began identifying high-water marks (HWMs). In September 2016, a cooperative study that focused on Odanah and surrounding areas, was done to further identify and survey HWMs and evaluate the magnitude of the flood, probability of occurrence, and extent of flood inundation. Near the flood study area are seven USGS continuous-record streamgages and six crest-stage gages (fig. 1).

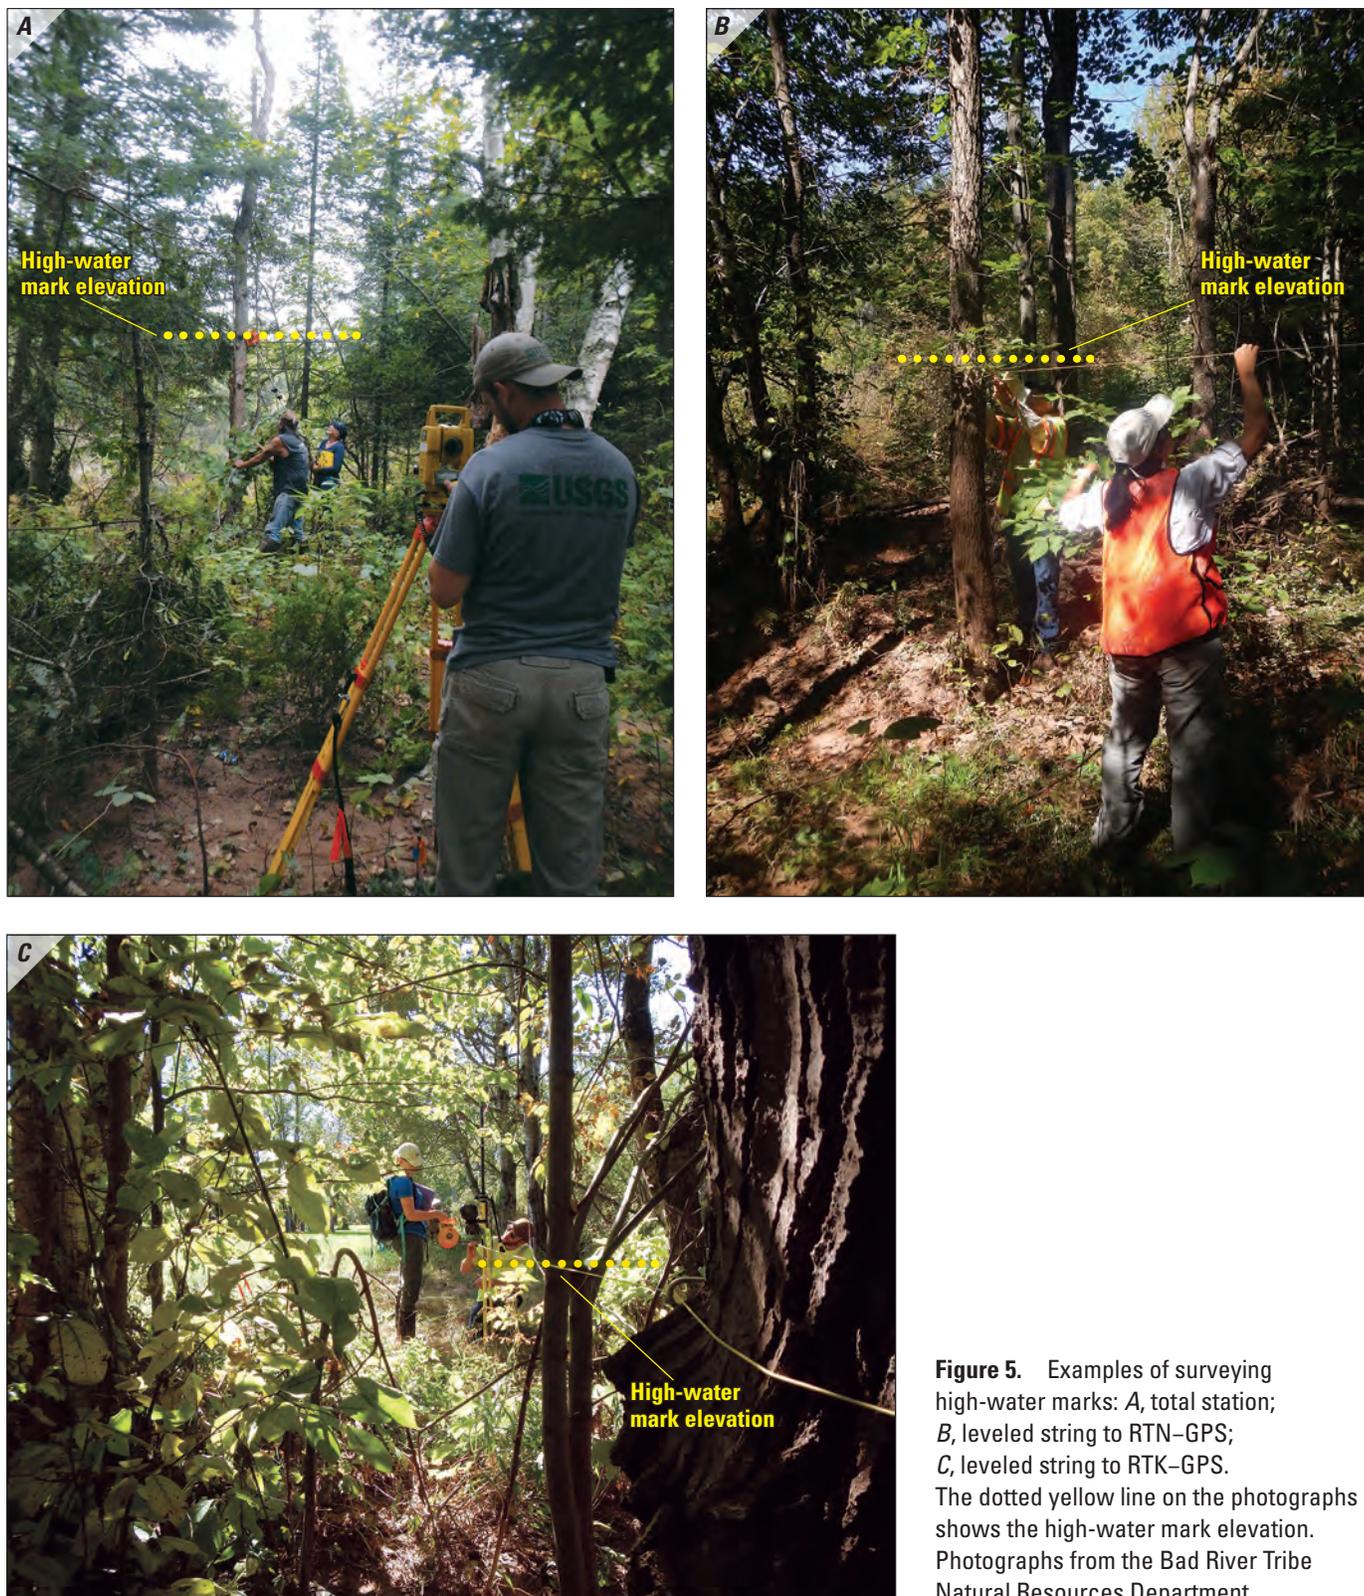
Figure 5. Examples of surveying high-water marks: *A*, total station; *B*, leveled string to RTN-GPS; *C*, leveled string to RTK-GPS. The dotted yellow line on the photographs shows the high-water mark elevation. Photographs from the Bad River Tribe Natural Resources Department.

The RTK–GPS and RTN–GPS surveys have a GPS rover unit on a 6-ft rod used to mark the coordinates of a HWM. Because most of the HWMs were on trees or next to buildings, the ability to set the GPS rover directly over a HWM to determine fixed-point coordinates was rare. A string, string level, and rod were used to accurately move a HWM elevation out from the blocked location to the rover (figs. 5A–5C).

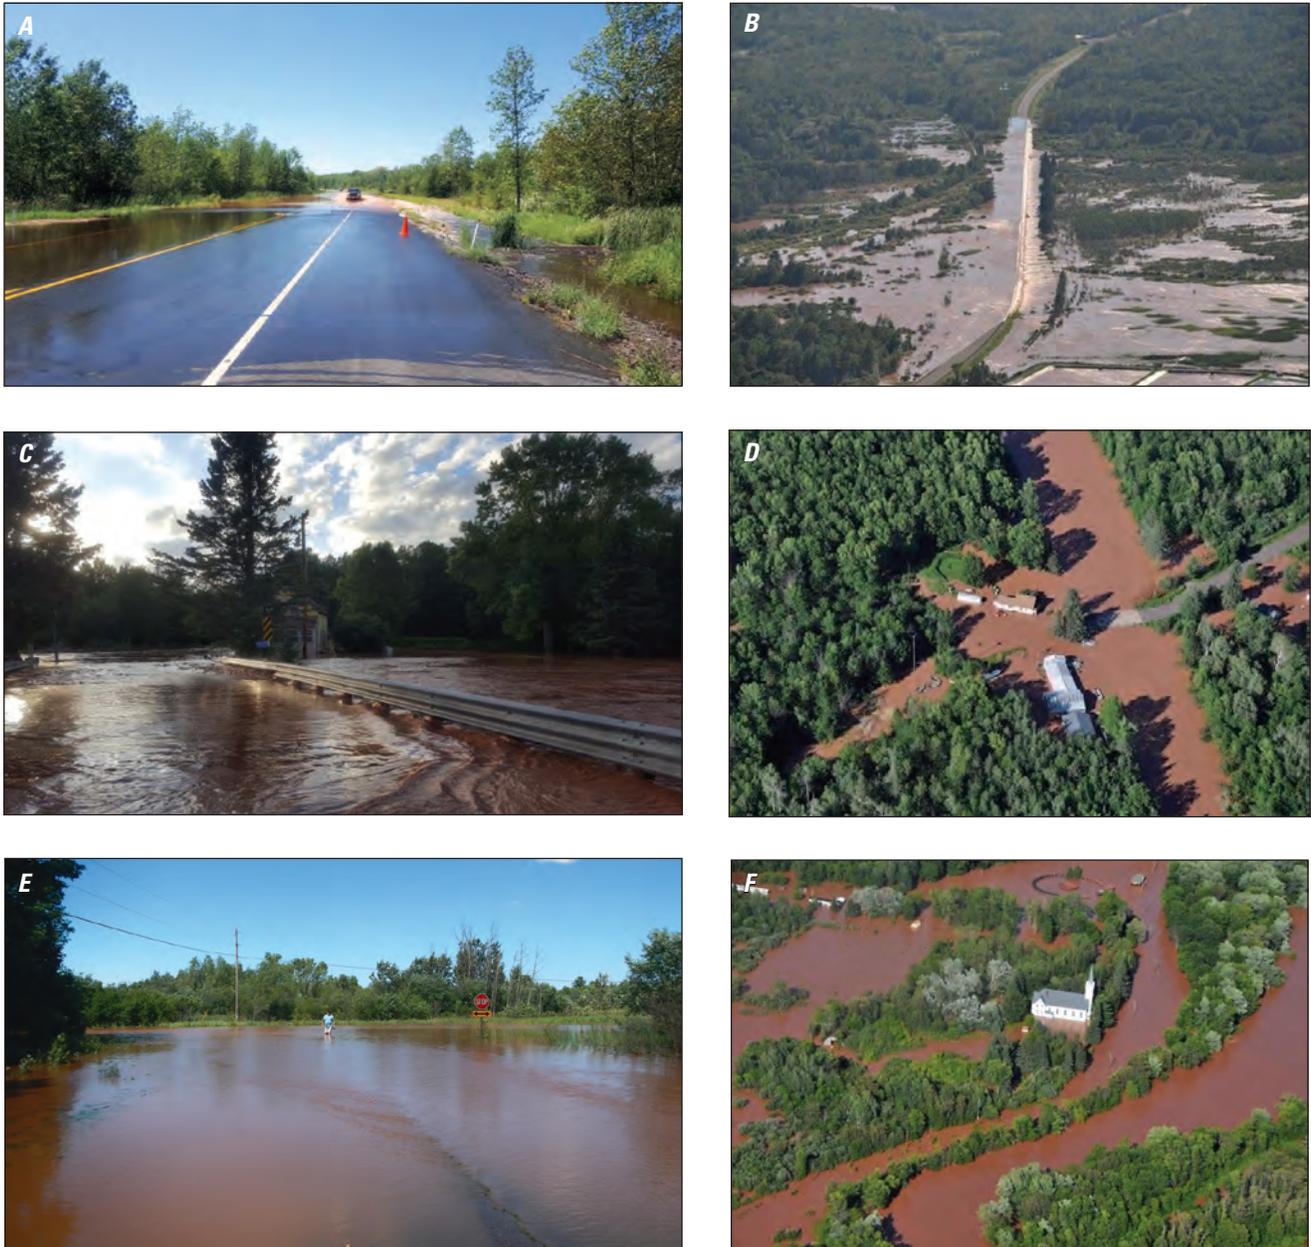
Figure 8. Photographs of flooding in the vicinity of Odanah, Wisconsin, caused by the combined floodwaters of the White and Bad Rivers. *A*, looking east at a flooded portion of U.S. Highway 2 east of the Bad River bridge crossing; *B*, aerial view of flooded portion of U.S. Highway 2 west of Kakagon Road; *C*, flooded portion of Kakagon Road looking east from the fish hatchery; *D*, aerial view of flooding of the Kakagon River at Kakagon Road crossing with fish hatchery on the west (left) side; *E*, looking north at a flooded intersection at Old Odanah Road and Old U.S. Highway 2; *F*, aerial view of flooding along Old Odanah Road, St. Mary Catholic Church, and powwow grounds. Photographs from the Bad River Tribe Natural Resources Department and Emergency Management.

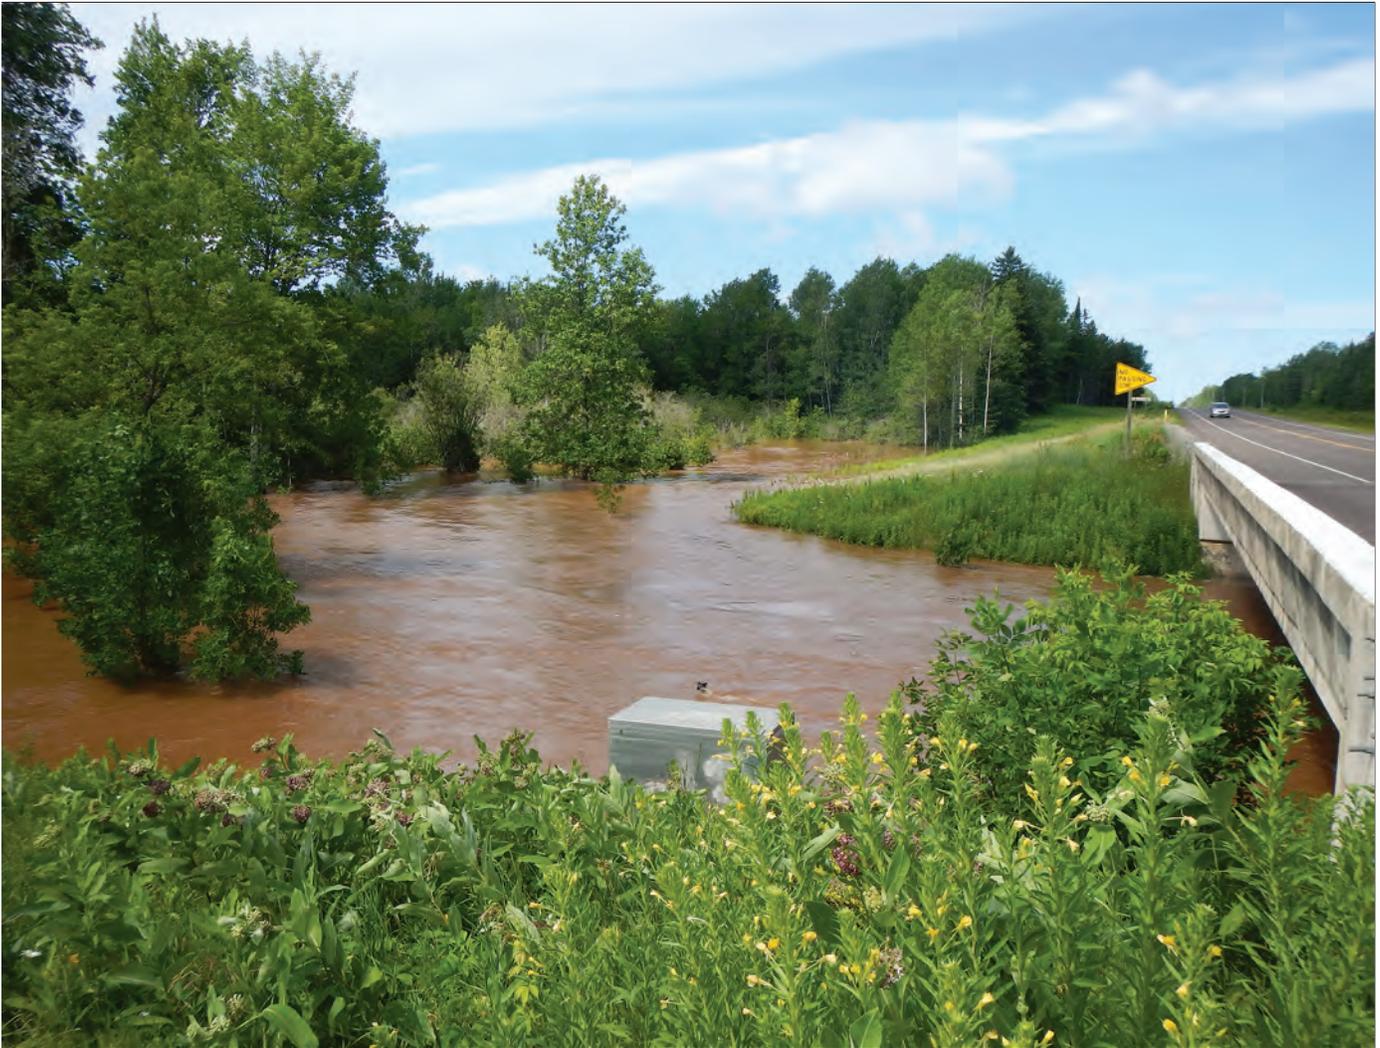
Figure 10. Photograph of flooded Beartrap Creek and the U.S. Geological Survey streamgage enclosure on July 12, 2016. Photograph by Naomi Tillison, Bad River Tribe Natural Resources Department.

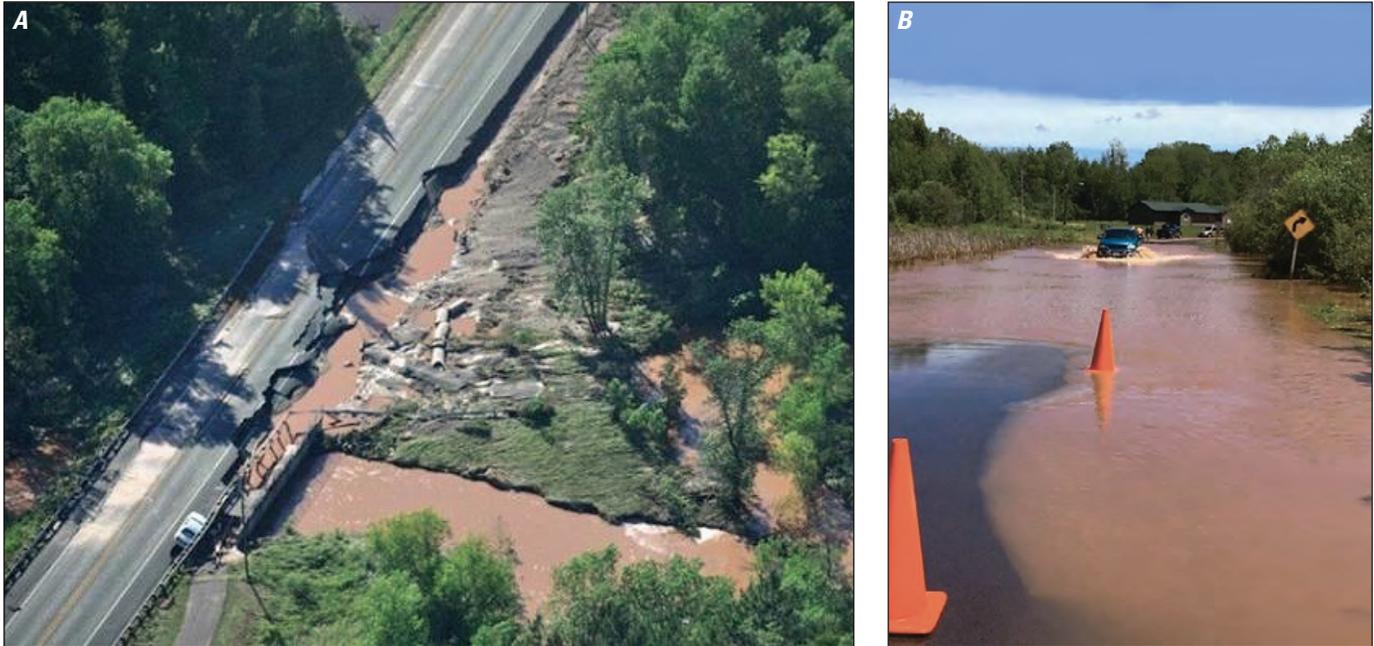
Figure 12. Photograph for the July 2016 flood for Odanah, Wisconsin, associated with floodwaters of Denomie Creek near the community of Odanah. *A*, flood damage at the U.S. Highway 2 bridge; *B*, flooded areas looking north along Maple Street. Photographs from the Bad River Band of Lake Superior Chippewa Tribe (<https://www.badriver-nsn.gov/2016-flood-update>).

Inundation mapping along the Denomie Creek was done near the eastern side of Odanah and the Bad River Lodge and Casino (fig. 11). The mapping started about 300 ft southwest of U.S. Highway 2 and about 1.3 miles downstream into the Bad River Slough adjacent to Lake Superior. The inundation depth map was developed from 12 HWMs. The water-surface elevation ranged from 618.93 ft (188.65 meters) at the downstream end to 634.84 ft (193.50 meters) at the upstream end. The U.S. Highway 2 bridge over Denomie Creek was partially washed out by the flooding (fig. 12A), and roads and buildings were inundated in the residential areas in the community of Odanah (fig. 12B). The inundation map shows water totally over U.S. State Highway 2 from Denomie Creek for about a 50–100 ft section (fig. 11). Mud and washouts along the north side of the road indicate that possibly 400 ft of U.S. Highway 2 was inundated (fig. 12A).
