**IN THE UNITED STATES DISTRICT COURT
FOR THE WESTERN DISTRICT OF WISCONSIN**

DECLARATION OF NAOMI TILLISON

The History of the Check Valve Project

Check Valve Installation

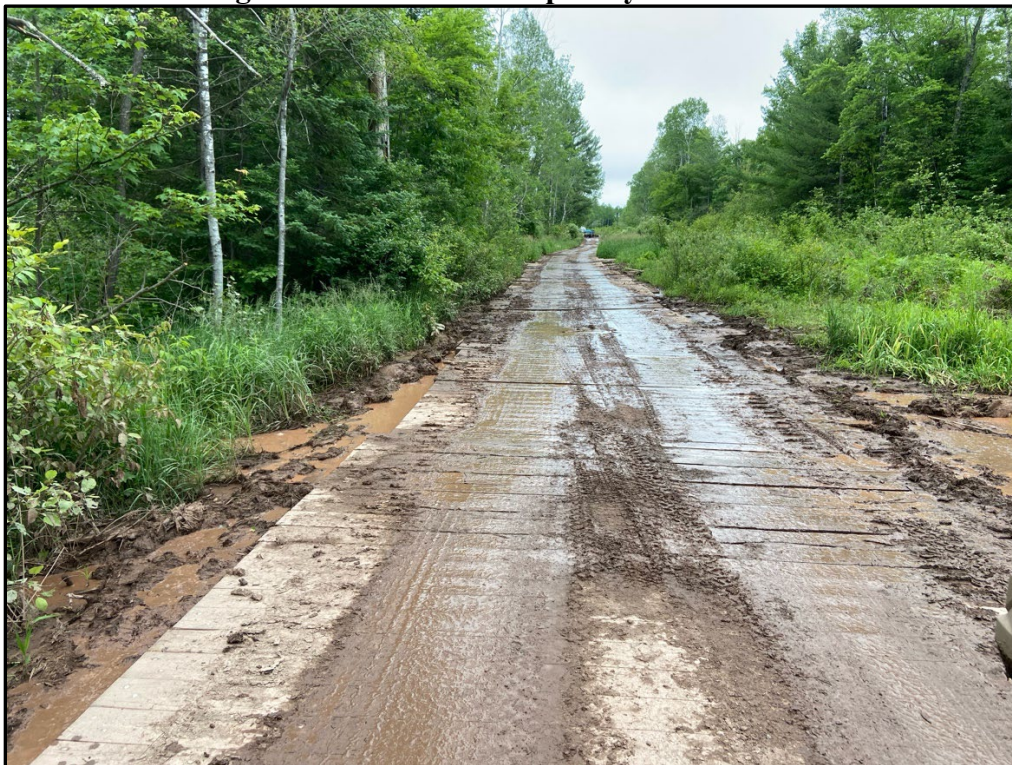
Fig. 1: Check Valve Temporary Access Road

21. The installation of the check valve was a major undertaking. It required the construction of 1.6 miles of temporary roadway to enable heavy machinery to access the remote Reservation site where the check valve would be installed. This resulted in the destruction or impairment of over 4 acres of wetlands and streams over the course of the 3 months of construction. The project resulted in longer-lasting impacts to wetlands, streams, and wildlife than proposed by Enbridge, with the restoration phase of the project still continuing into 2026. Much of the damage is being repaired, through restoration efforts under the guidance, oversight, and support of MNRD and its experts. But much of the damage is irreversible.

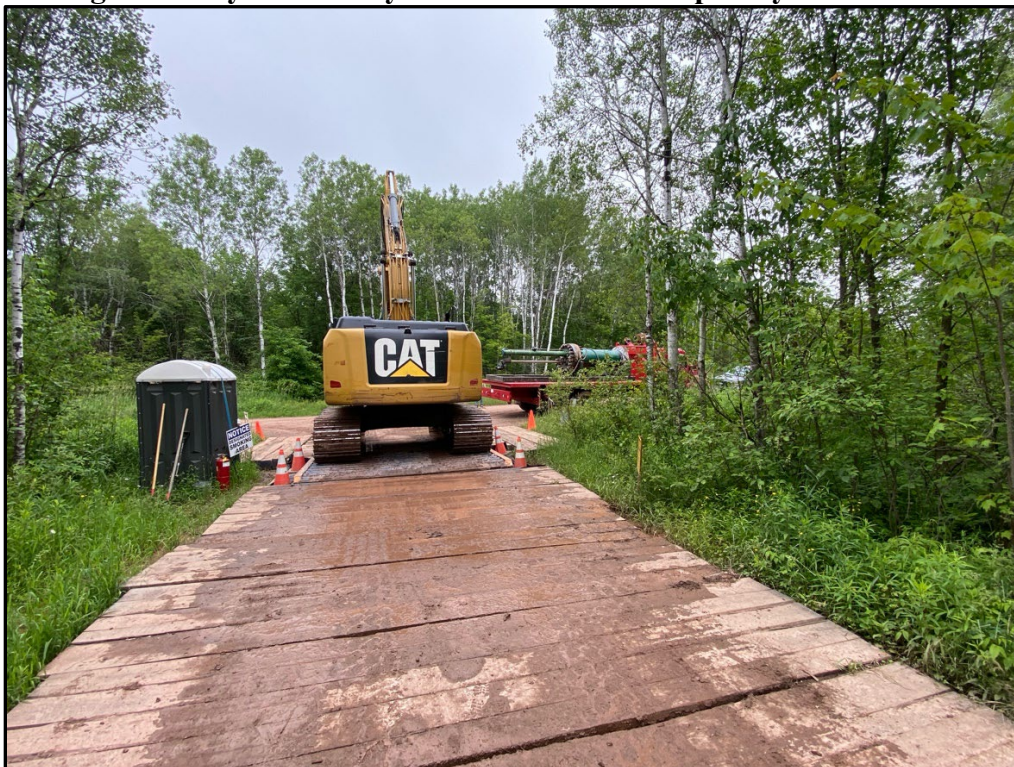
Fig. 2: Heavy Machinery on Check Valve Temporary Access Road

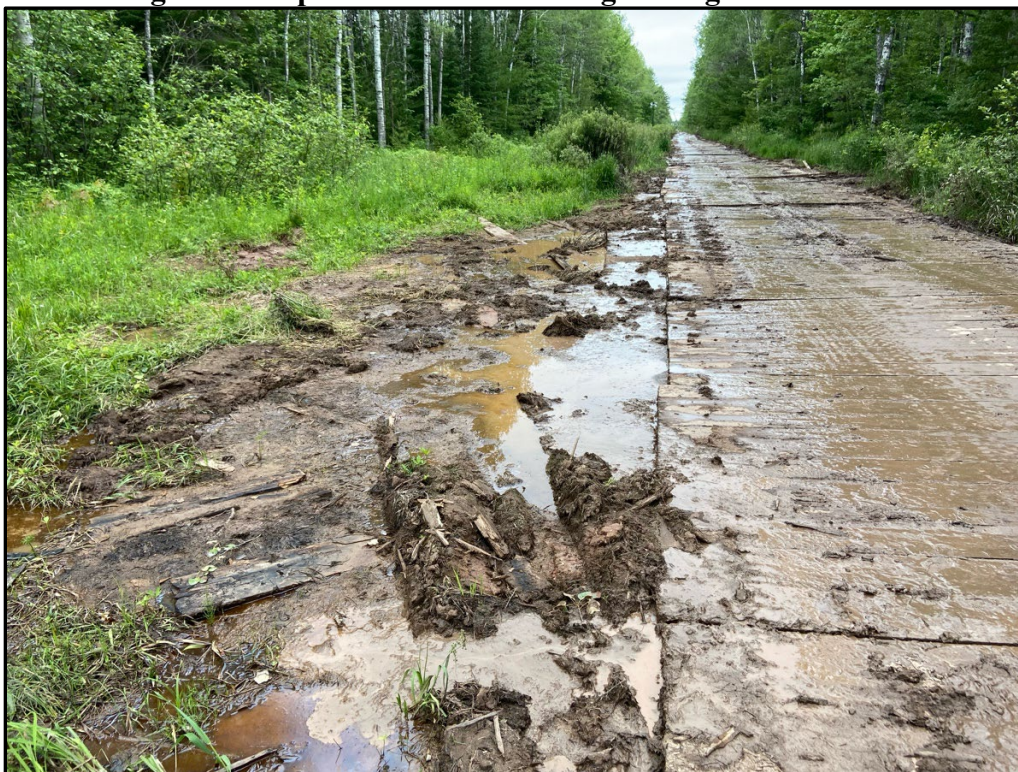
Fig. 3: Example of Wetlands Damage Along Access Route

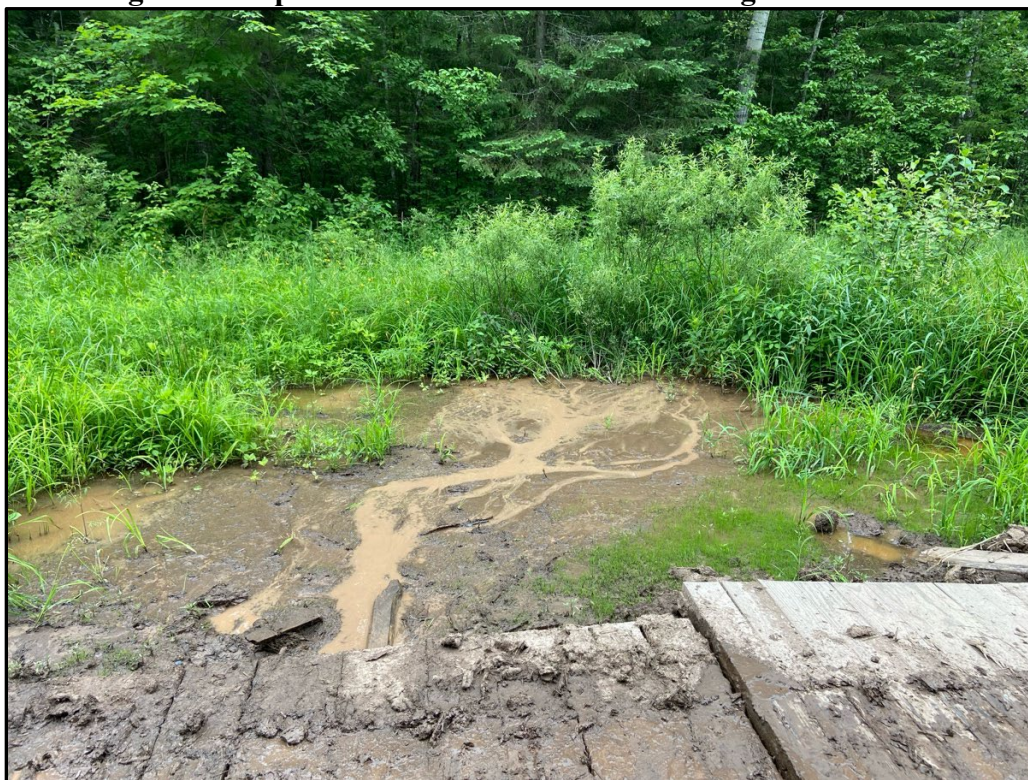
Fig. 4: Example of Watercourse Pollution Along Access Route

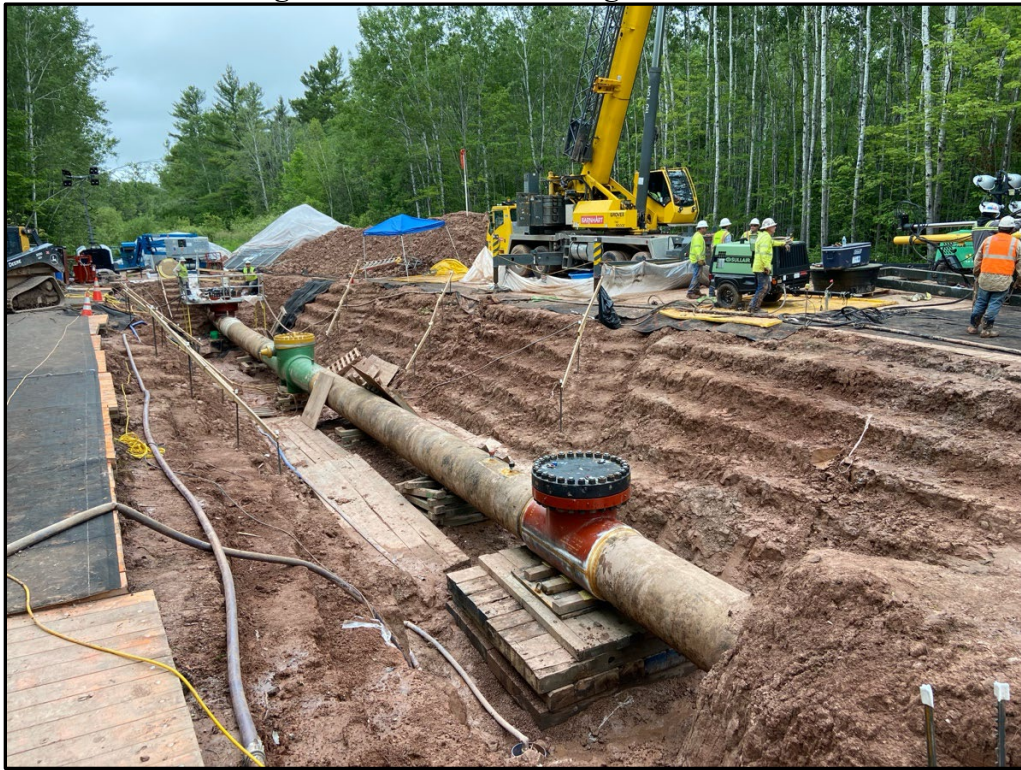
Fig. 5: Check Valve During Installation

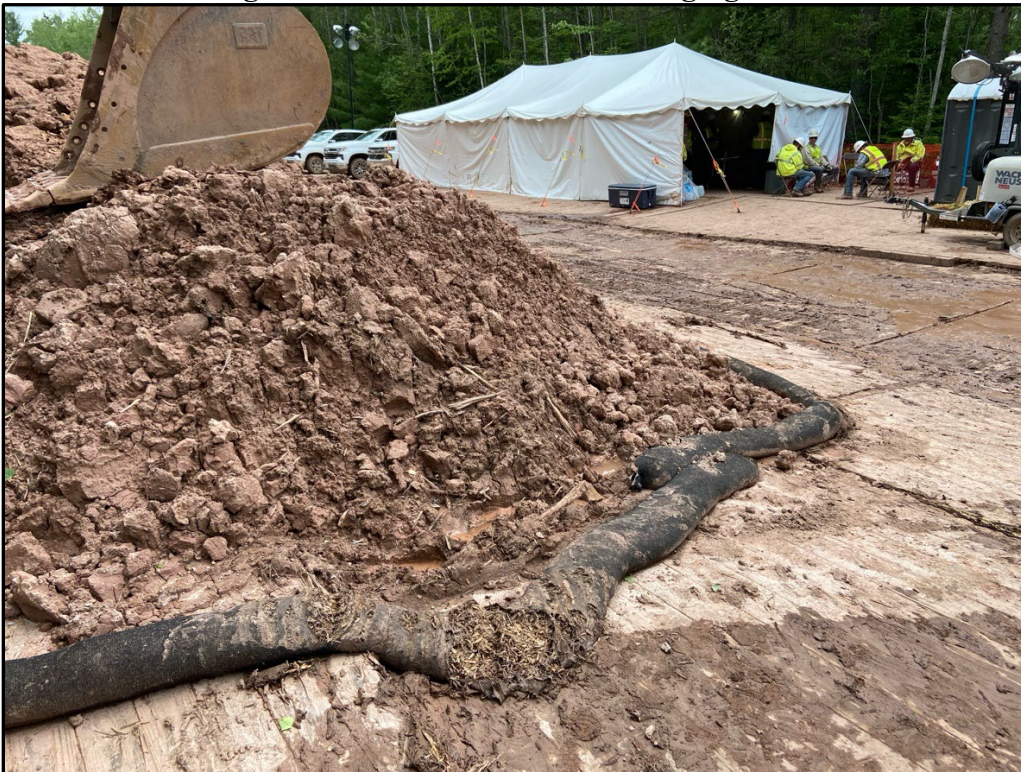
Fig. 6: Portion of Check Valve Staging Area

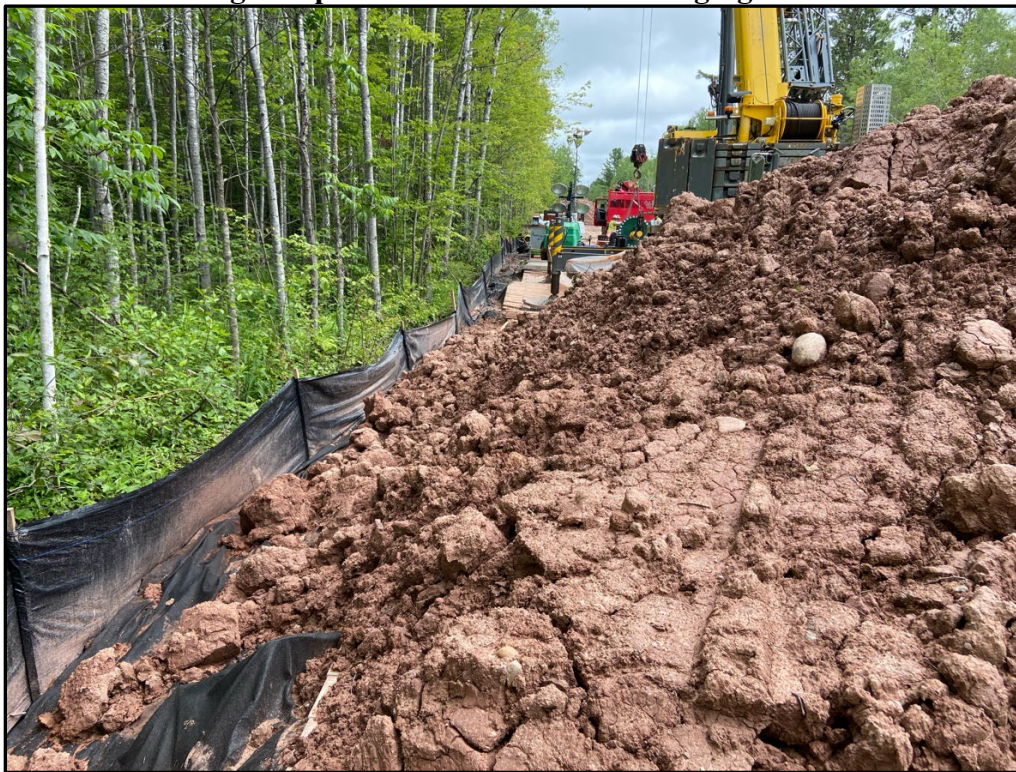
Fig. 7: Spoil Pile at Check Valve Staging Area

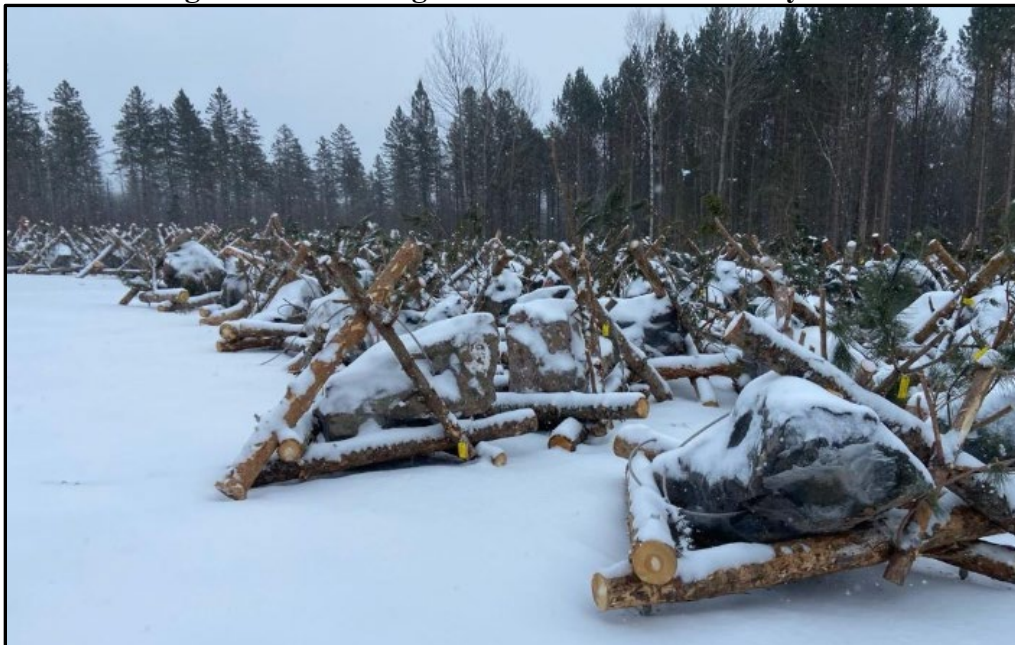
Fig. 8. Finished Log Jacks at Off-Site Assembly Area

30. 145 large jacks built of logs up to 12 inches in diameter enclosing boulders of roughly 6 tons, as well as 125 smaller jacks made of logs up to 8 inches in diameter and boulders of roughly 1.5 tons, were built at a nearby off-Reservation site.

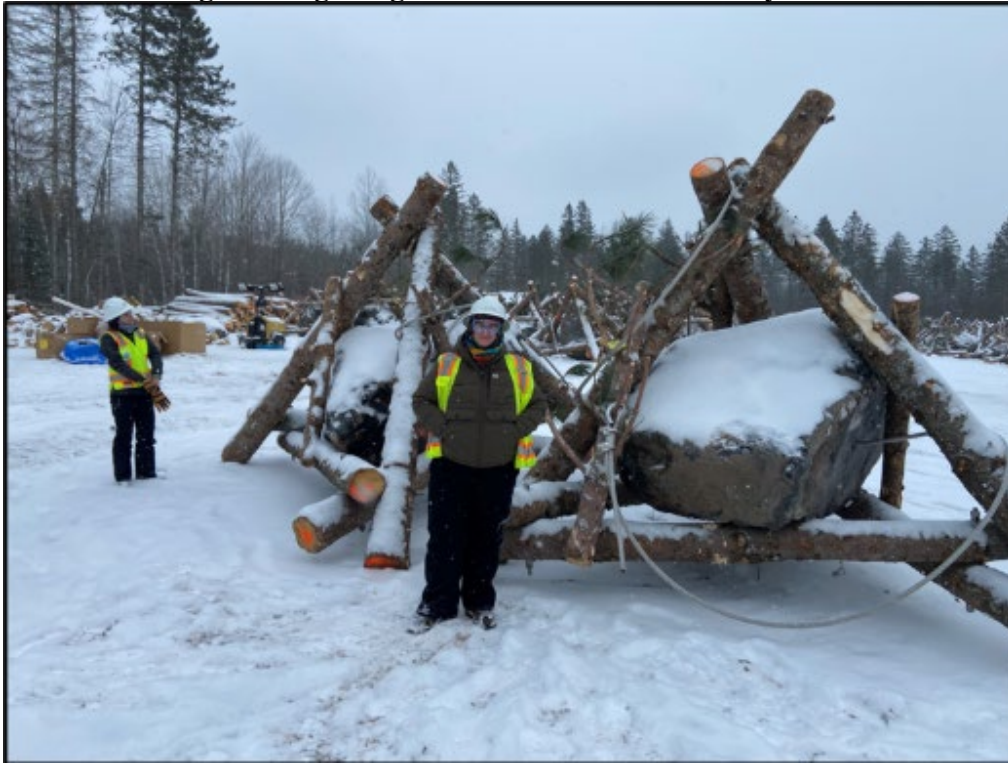
Fig. 9. Large Log Jacks at Off-Site Assembly Area

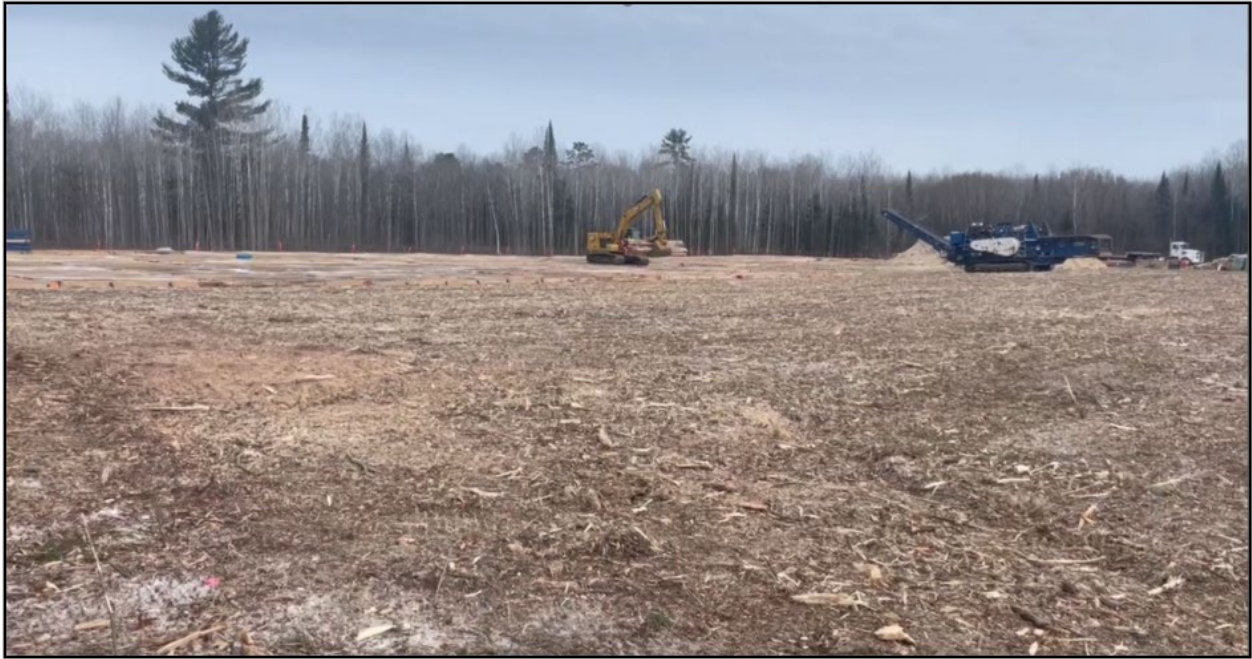
Fig. 10. Clearing and Chipping of Timber and Vegetation at Staging Area

32. An on-Reservation staging and helicopter landing area was constructed near the Bad River. Over 6 acres of hardwood and coniferous forest and other habitats were chopped to the ground and covered with heavy matting for that purpose. Over 2 acres of Bad River's floodplain forest were also cleared for access and workspace.

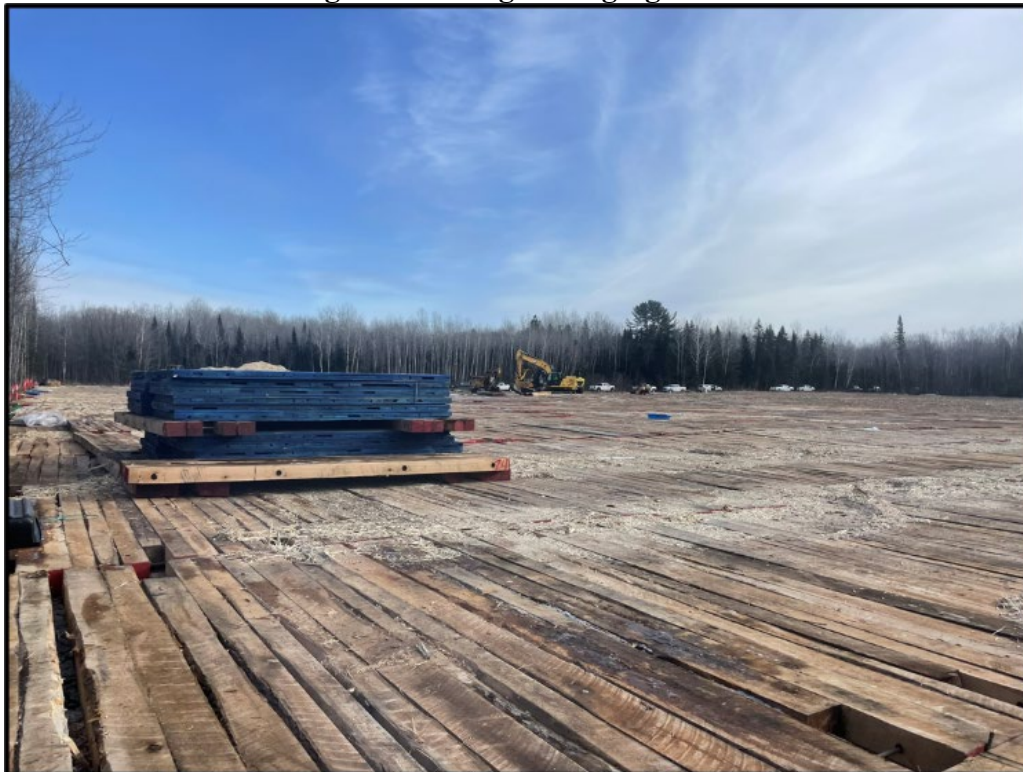
Fig. 11. Matting of Staging Area

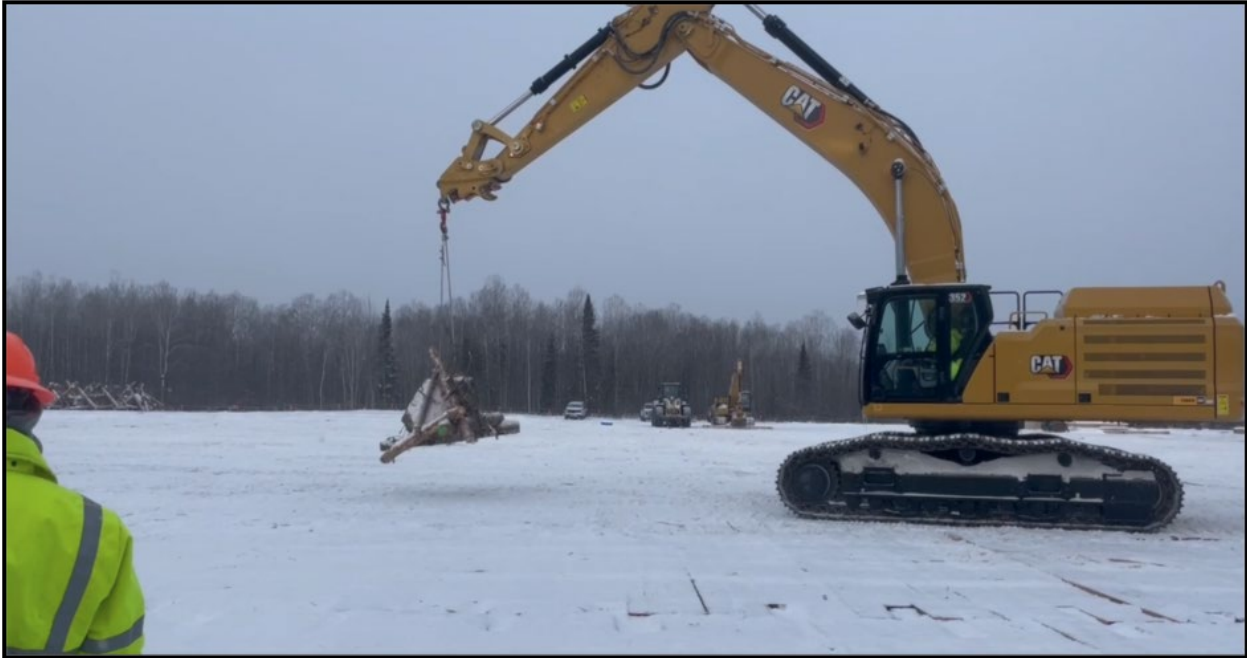
Fig. 12. Lift Test of Small Log Jack at Staging Area

34. The log jacks were transported from the assembly area to the on-Reservation staging area by semitrucks, cranes, and other heavy machinery.

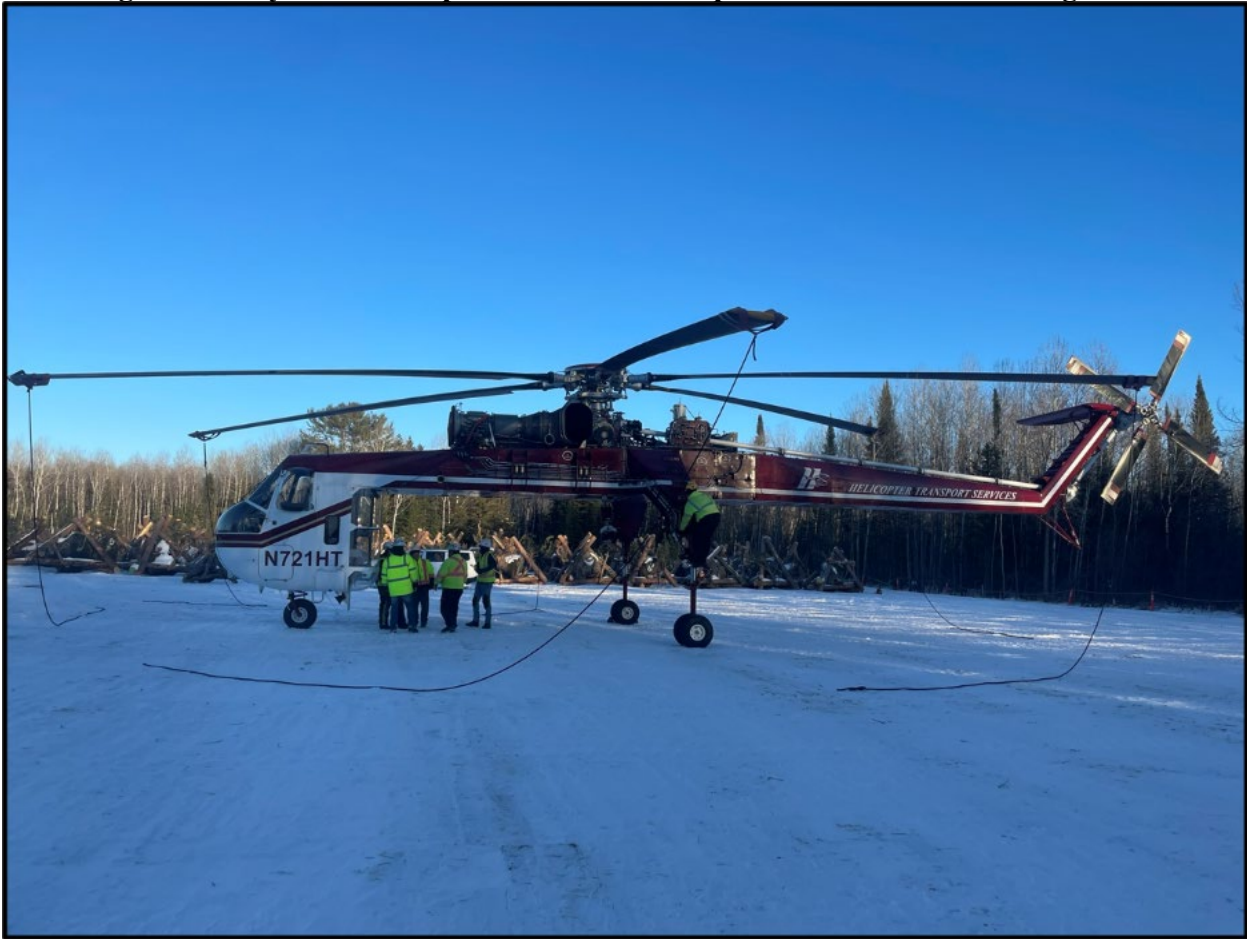
Fig. 13. Heavy-Lift Helicopter Used for Transport and Placement of Log Jacks

39. A Sikorsky S-64 Skycrane twin-engine heavy-lift helicopter (the civilian version of the U.S. Army's CH-54 Tarhe) was specified to transport the log jacks from the staging area to the meander, over two-thirds of a mile away, necessitating the closure of a major Reservation road in the flight path.

41. This helicopter lowered the log jacks to workmen on ground at the meander, who guided the log jacks in place, one by one, over the course of around 470 flights over a week, to ultimately build a revetment 309 feet long in the Bad River and along its banks that consisted of 1,812 logs and 235 boulders bound together by stainless steel bolts and chains.
